ARMAMENT RESEARCH AND DEVELOPMENT
ESTABLISHMENT

A.R.D.E. REPORT (S) 26/55

Investigation of Accidental Explosion of 1000 lb.
Bomb at R.A.F. Station Marham

October
1955

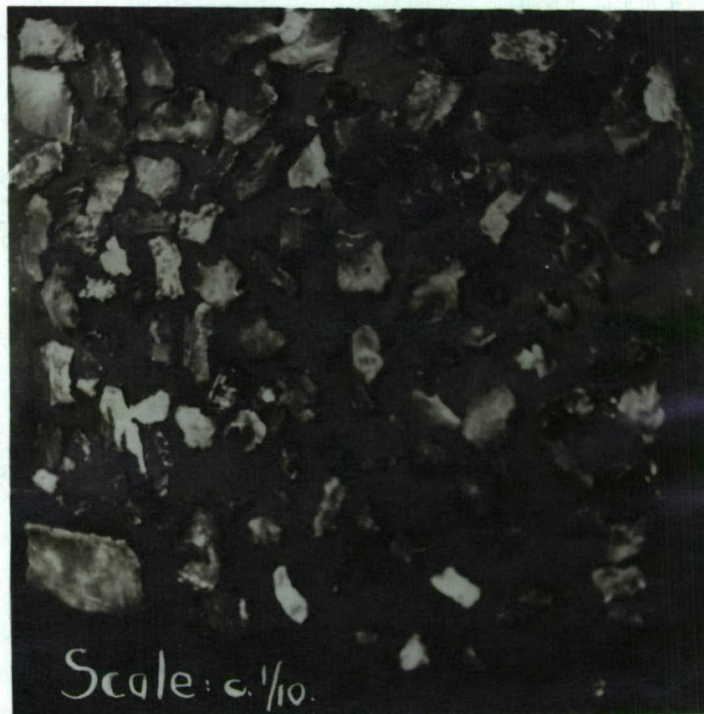
The fragments of the bombs (photographs 1 and 2) varied in size from 1 ft. in length and 6 in. in width to very small pieces. Many bore evidence of detonation, (photograph 3C) and among these were some which had originated from the nose and base of a bomb. Fragments from nose and base were found which had either been driven violently into concrete or were produced when

1. Fragments of bomb recovered after the explosion at
Marham

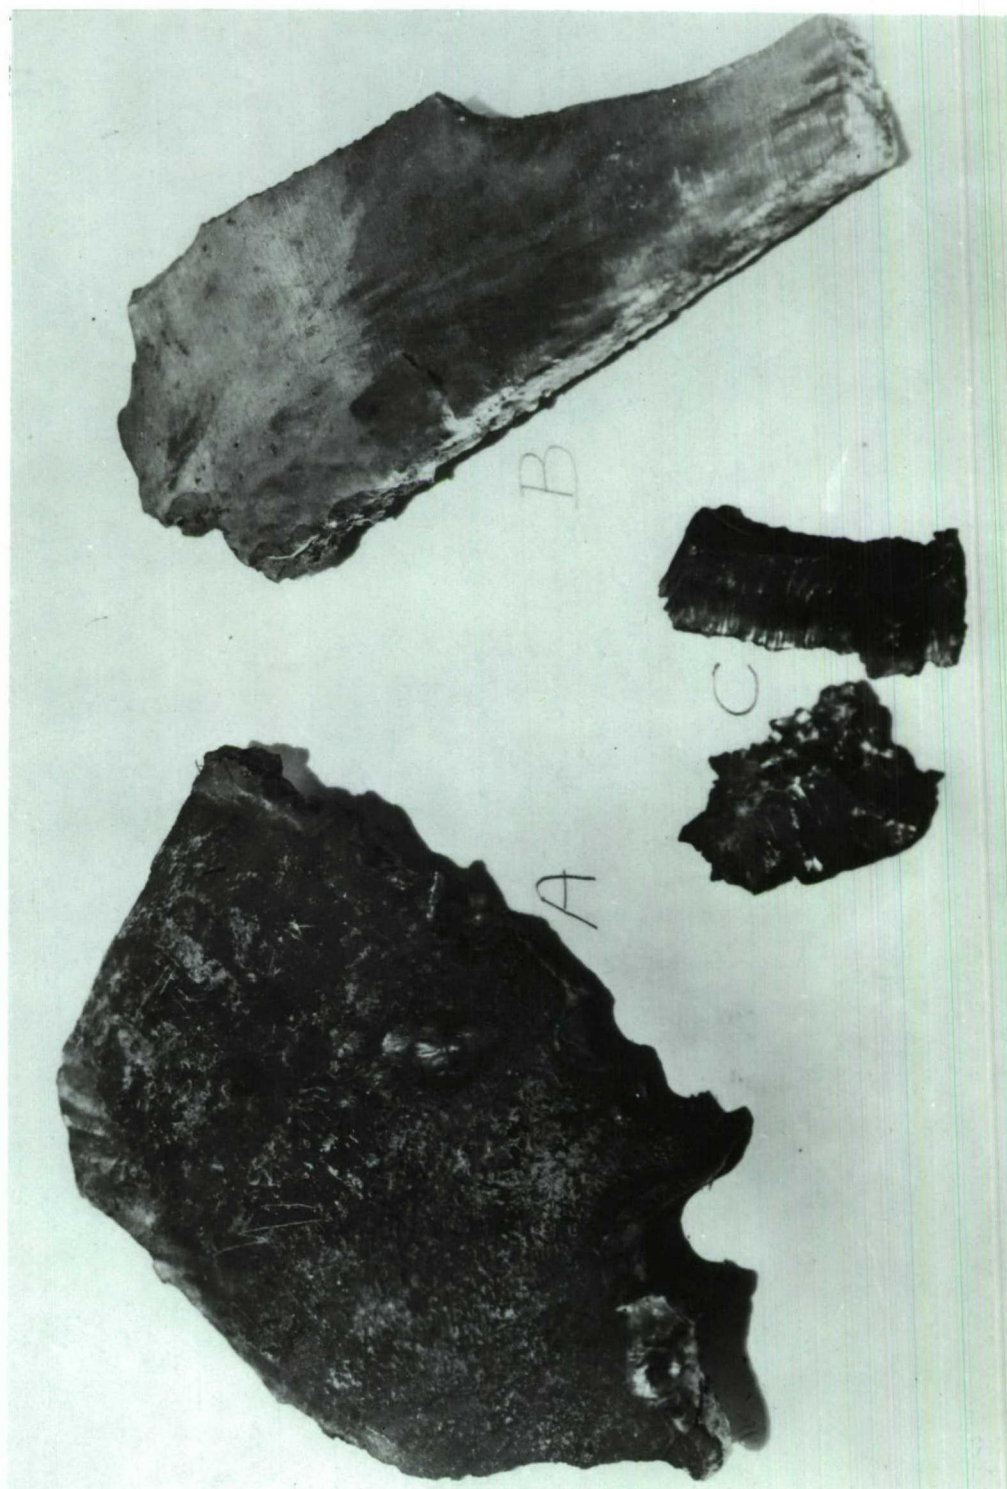
3. Fragments of bomb recovered after the explosion at Marham

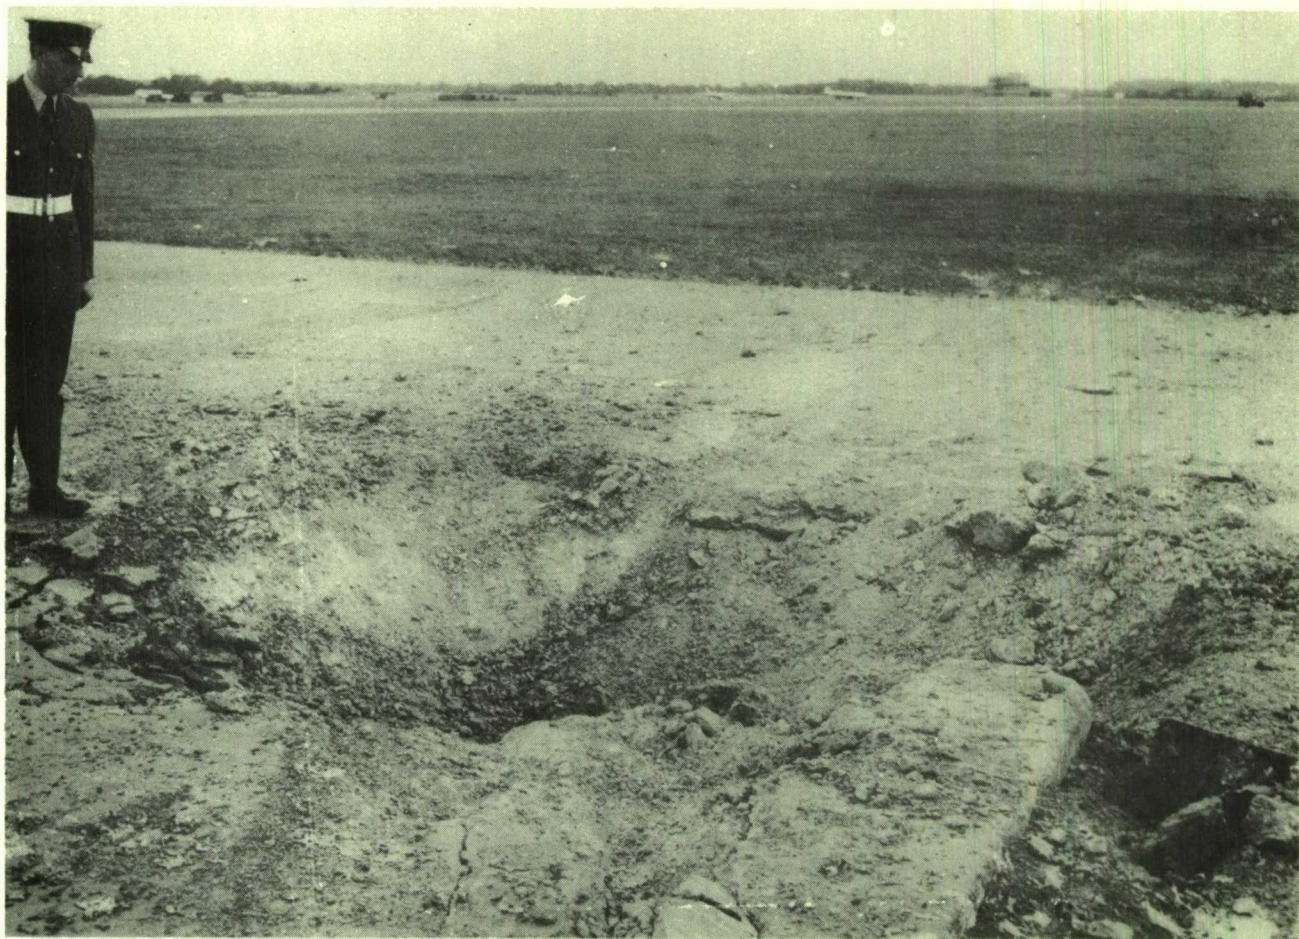
The general inference was that an ignition occurred somewhere along a bomb body - actually from descriptions of the crater (photographs 4 and 5) the port bomb - which built up to detonation in the direction of nose and base. This would account for the presence of large fragments with marks of ignition on the inside surface (photograph 3B). The presence of other large fragments on which the exterior paint was still intact and which showed signs of fragment attack (photograph 3A) suggested that the second bomb was initiated by the explosion of the first.

4. The crater from the explosion at Marham

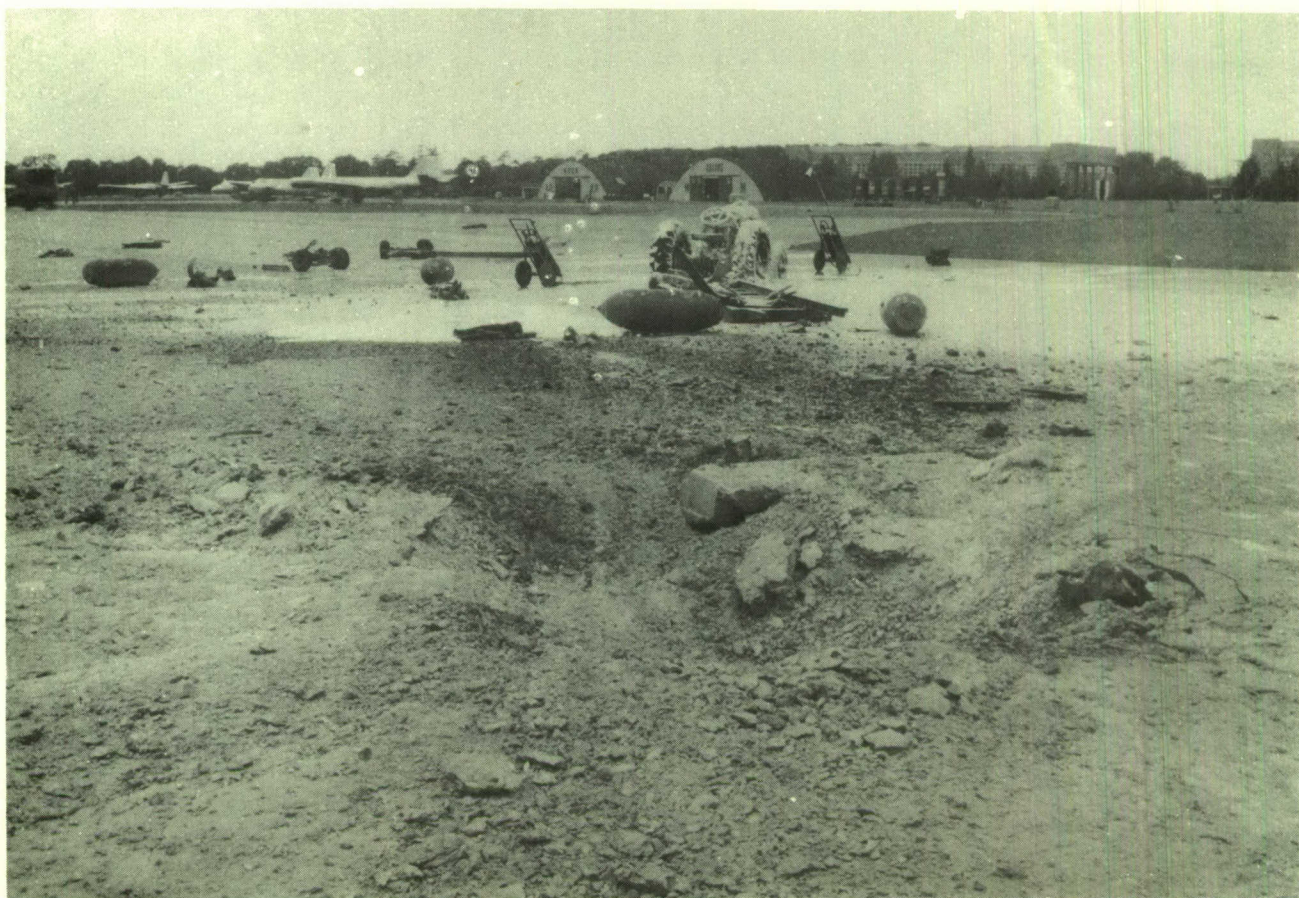
5. The crater from the explosion at Marham showing damaged bombs

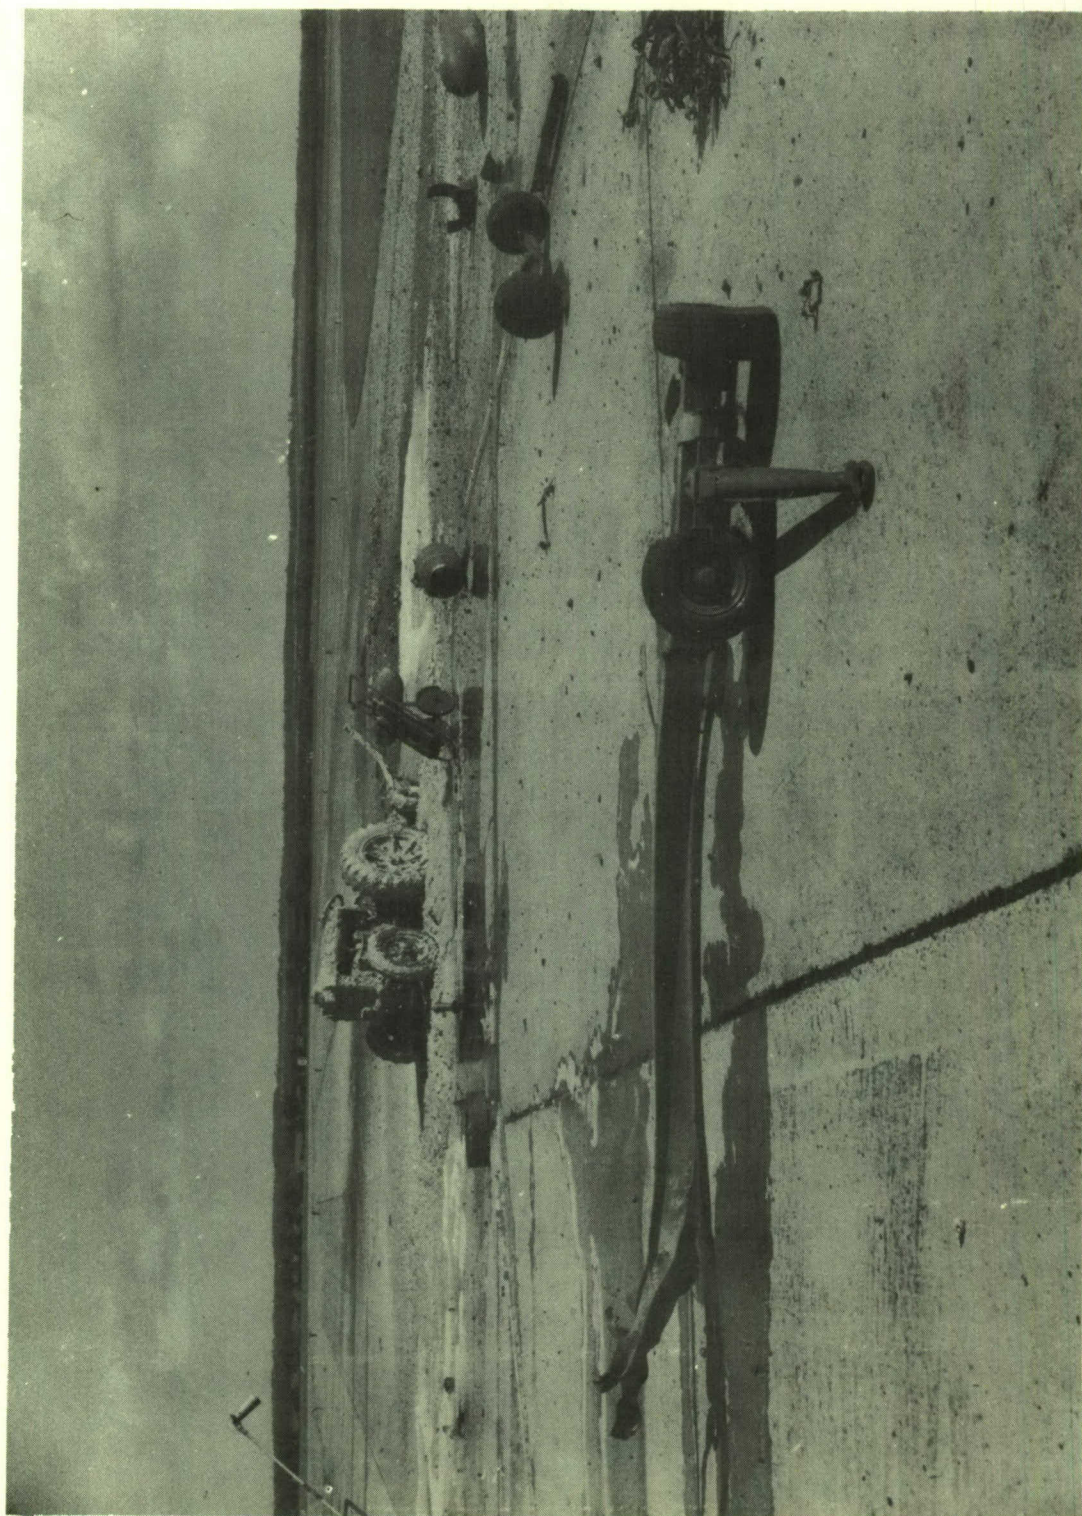
The remains of the bomb trolley were examined. The force of the explosion was directed mostly forwards, the trolley rails and main frame members being twisted outwards and slightly downwards. These rails and main frame were intact up to a point which would be beneath the centre of the bombs when resting normally (photograph 6), but the rear portions could not be identified. The right hand side of the rear axle was recovered from the crater showing signs of an explosion above it. The left hand side was not recovered. The damage is consistent with the explosion of a bomb displaced from the cradle and resting above the rear axle rather than with the explosion of a bomb in its correct position. The two positions are shown in photographs 9 and 11.

6. The rear bomb trolley after the explosion at Marham

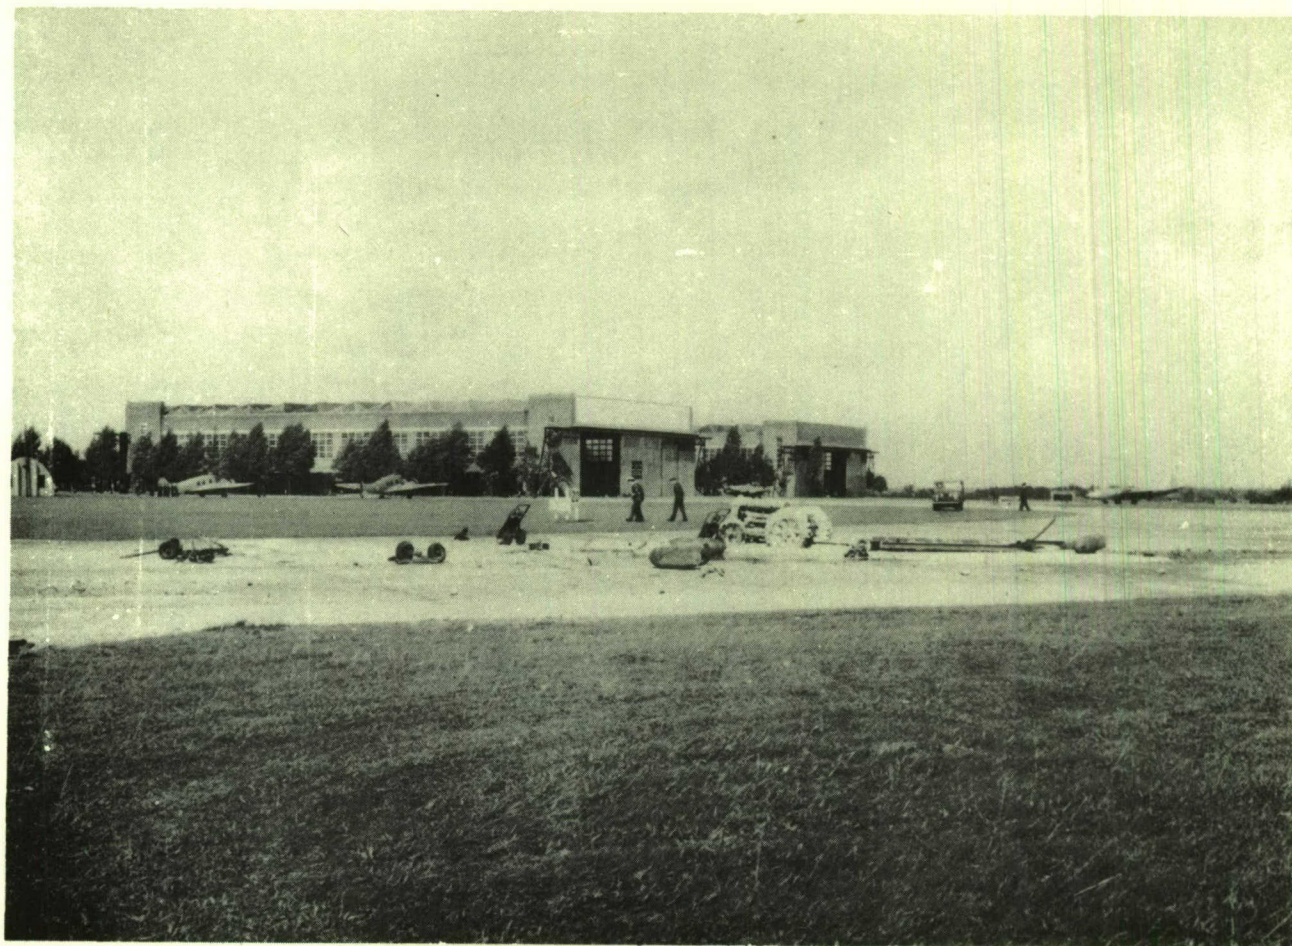
7. General view after the explosion at Marham

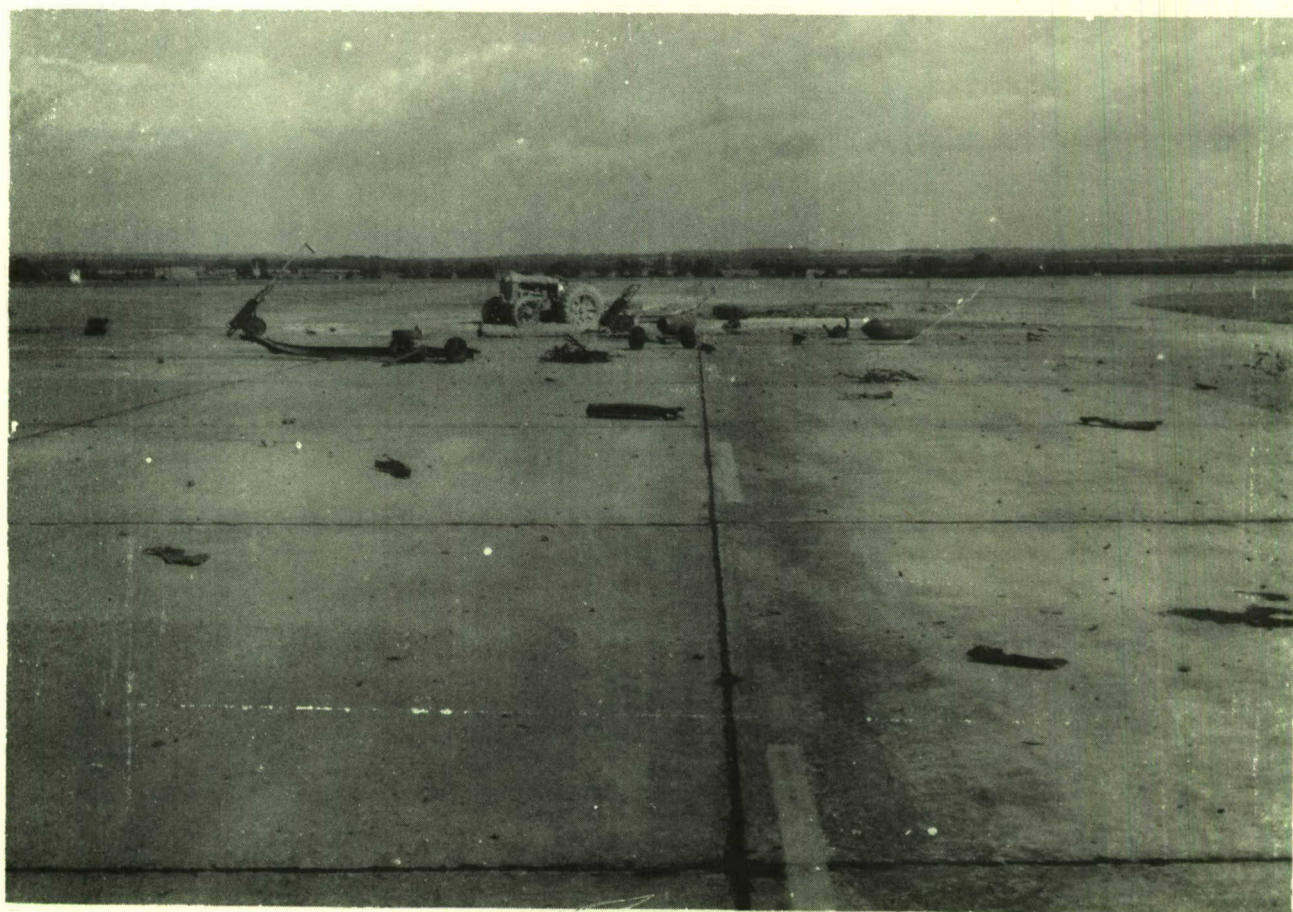
8. General view after the explosion at Marham

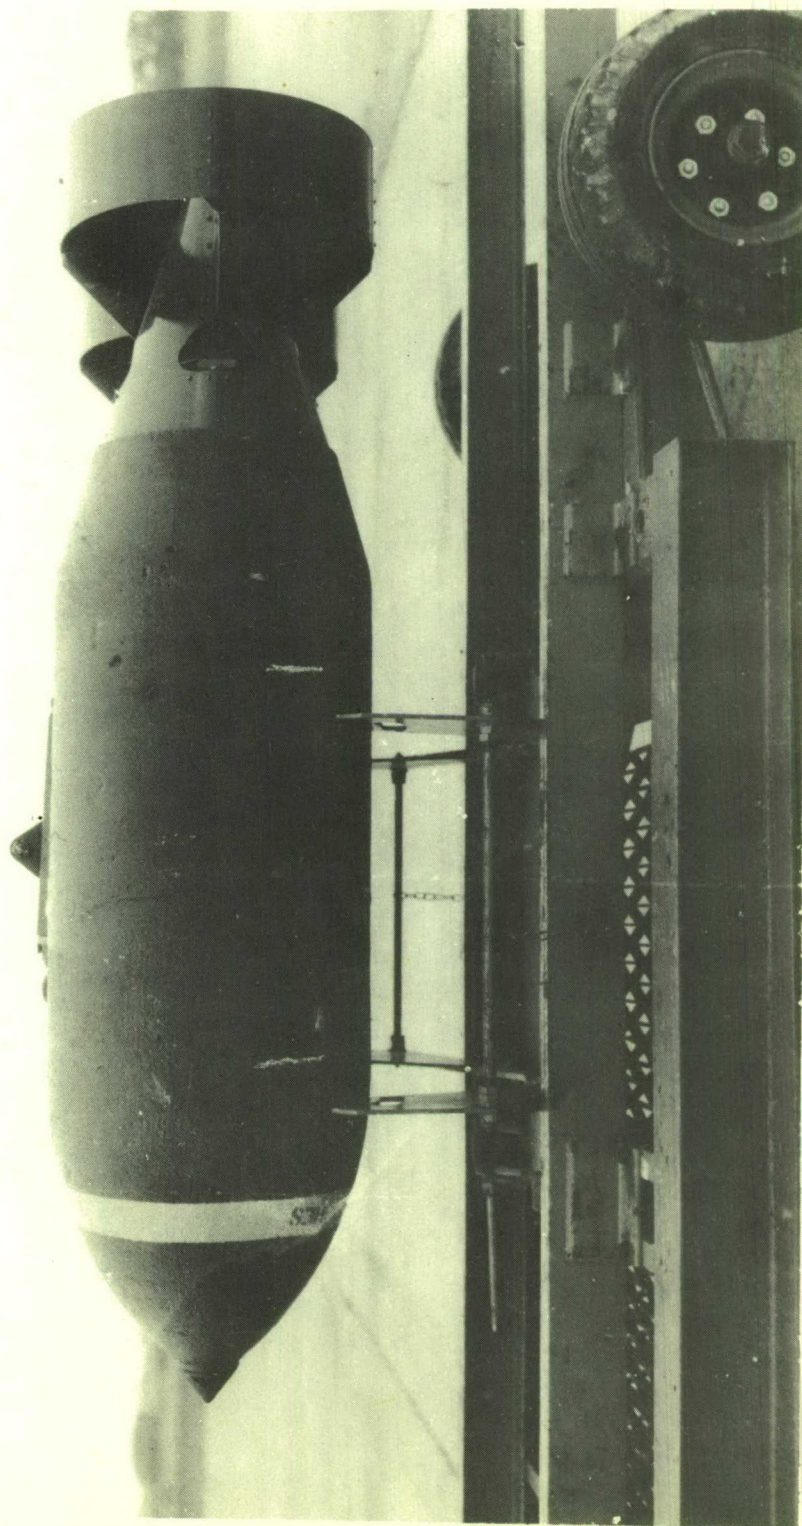
10. Bombs on cradle of trolley showing beginning of backward movement

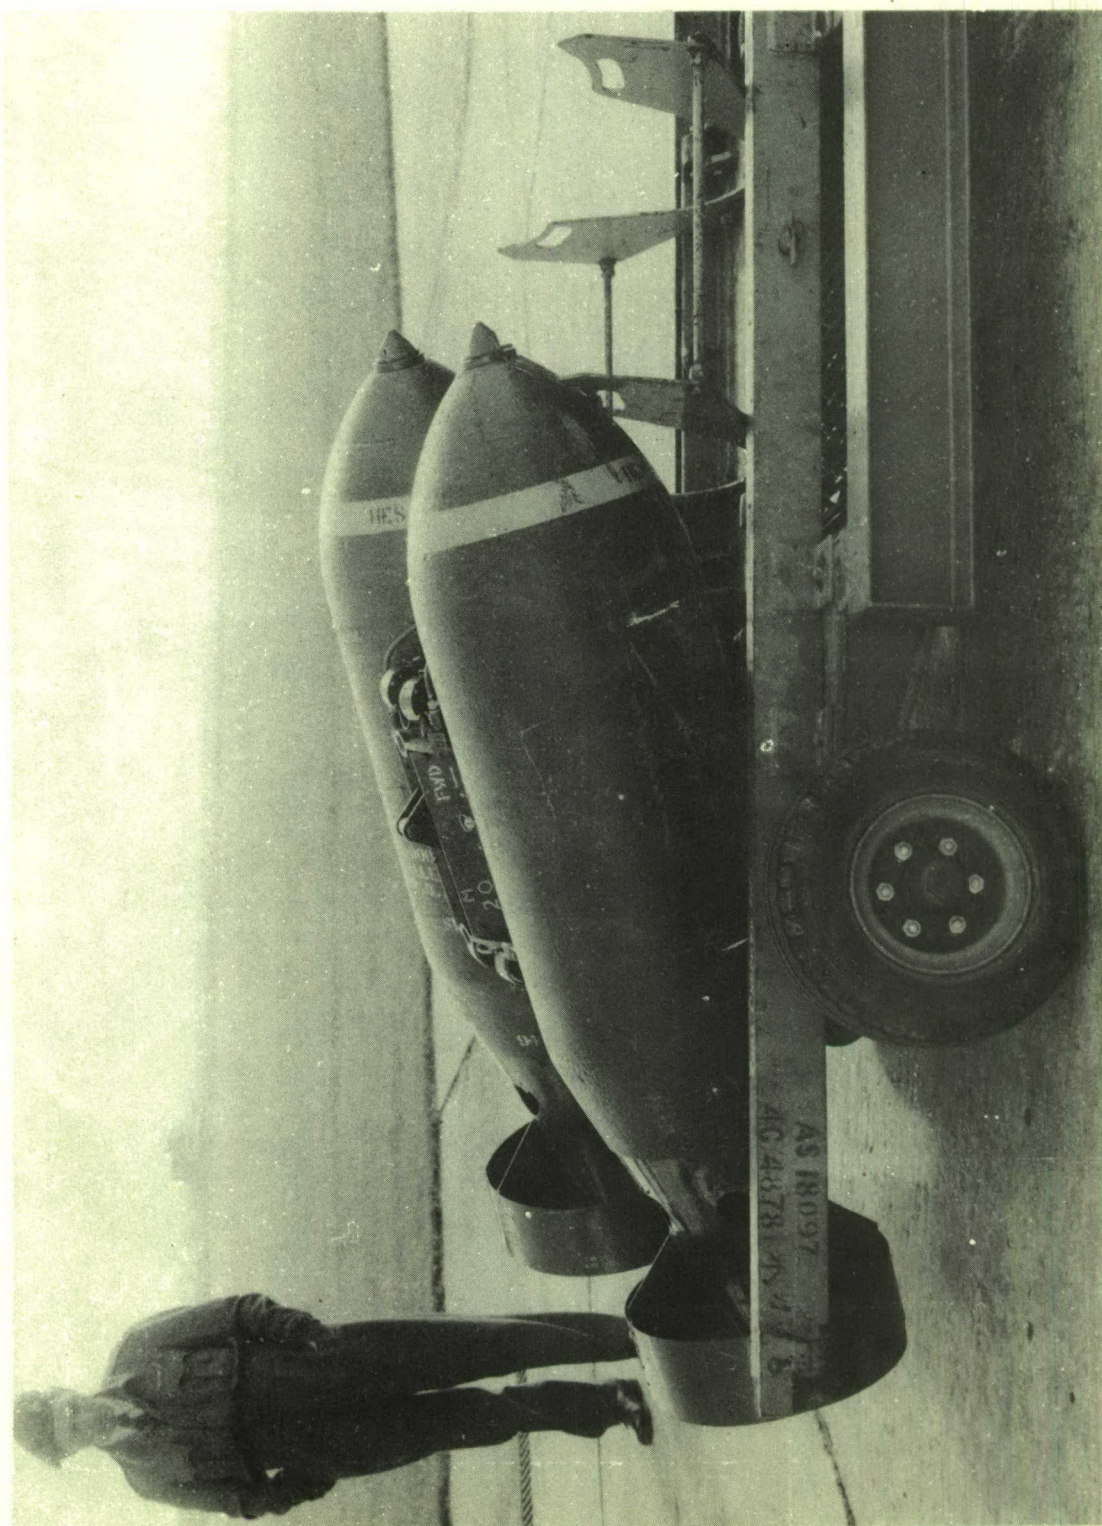
11. Bombs after falling off cradle of trolley

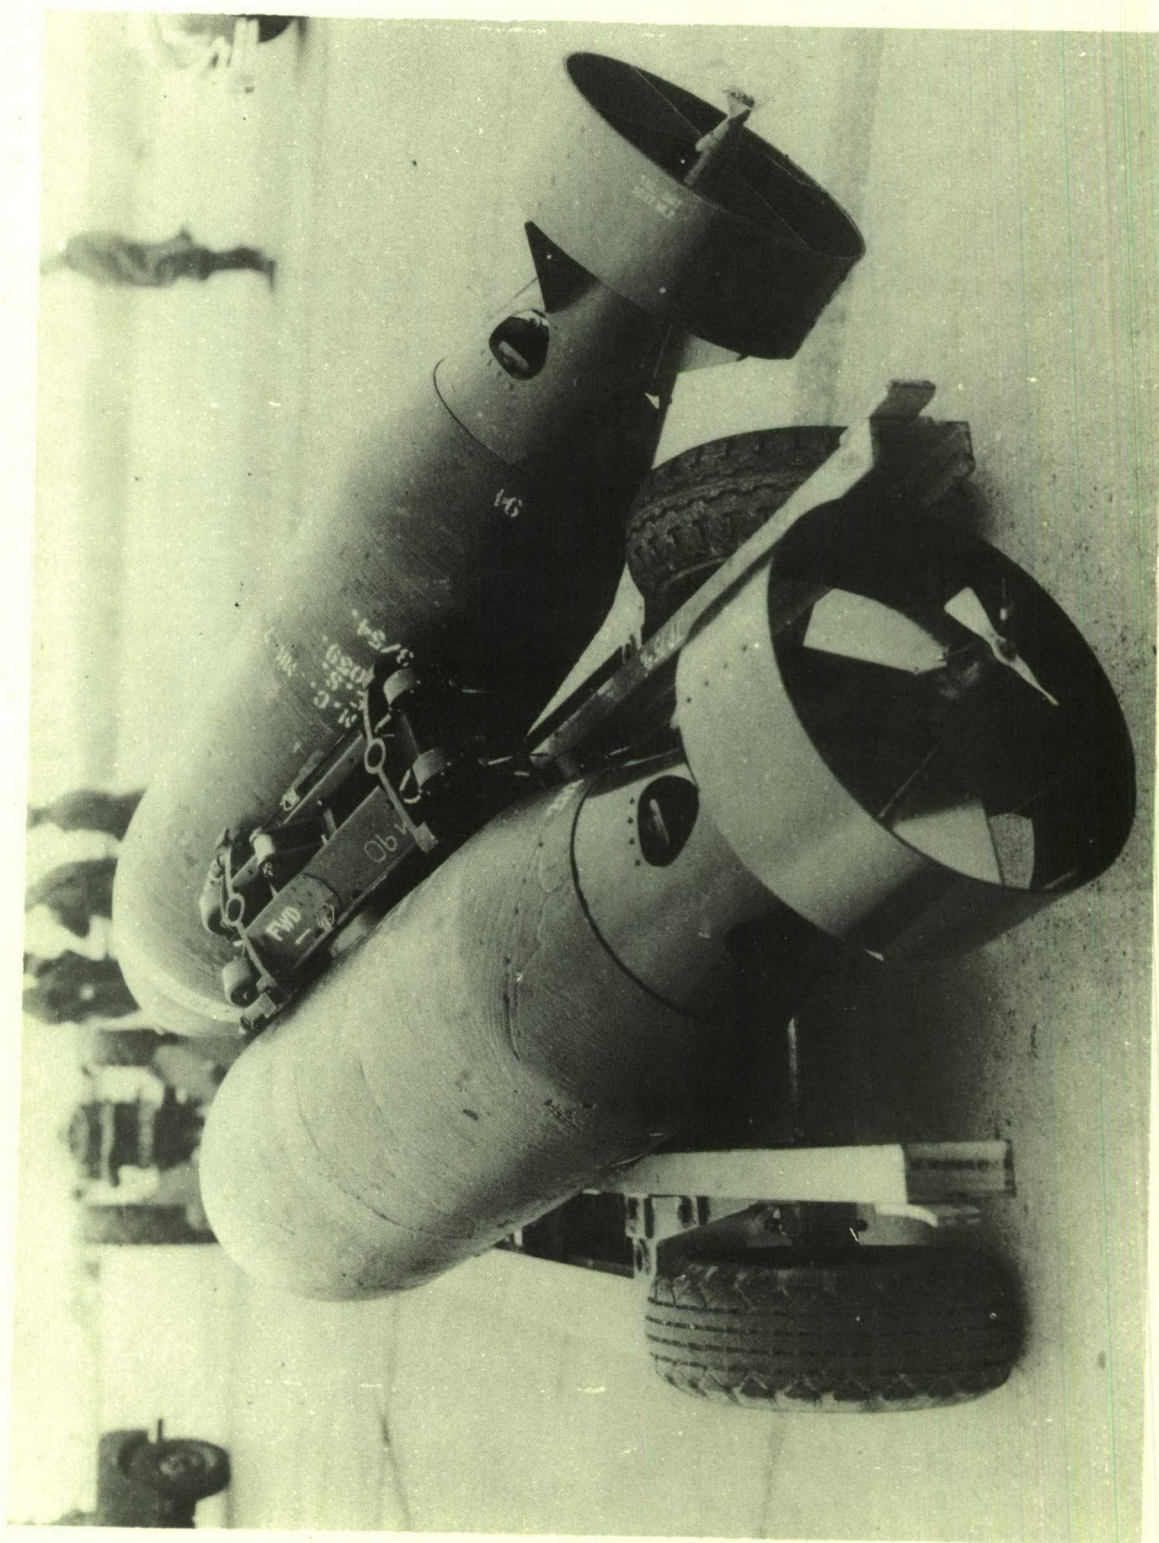
12. Bombs displaced into an unstable position

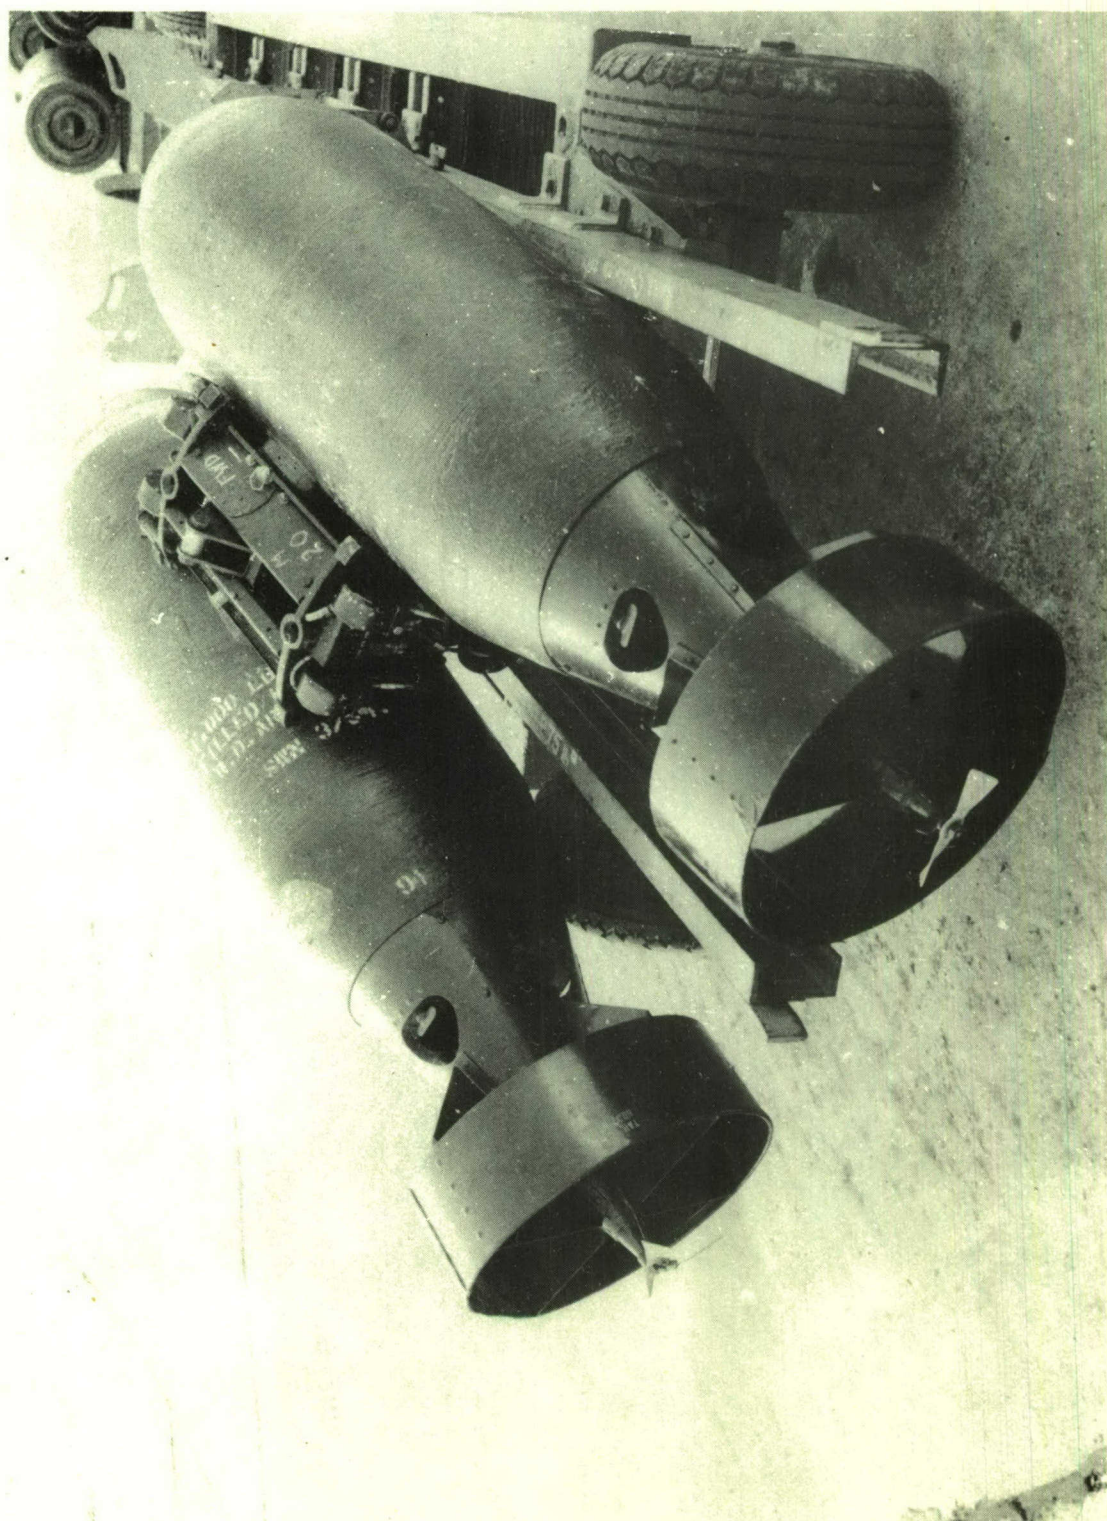
13. Bombs displaced into stable position. Port trolley
tyre rubbing on bomb

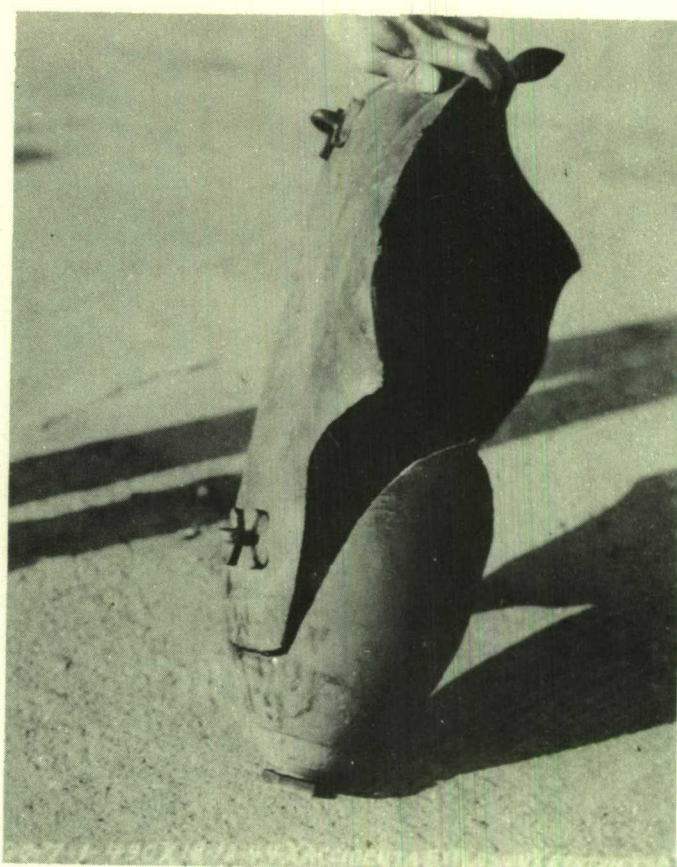
It was known from exploratory trials of a previous incident carried out at No.3 M.U. Milton, that appreciable local heating could be produced by the friction of a tyre on a bomb, and it was thought possible that this might be the cause of the explosion. The same suggestion had previously been made by the American Office of Ordnance and Armament to explain an explosion of a 100 lb. G.P. bomb filled T.N.T. at the U.S. 8th Air Force station (Eye) on 16th October 1945. There, a trailer was loaded with thirty-four 100 lb. G.P. bombs, unfuzed, and towed about 850 yards until, on entering the runway, one bomb exploded. It was thought that in going out of the bomb revetment the right rear wheel of the trailer hit a bump, causing the bomb nearest to it to shift and rest against the tyre. The explosion was of a very low order, no damage being done to the trailer bed, and no other bombs on the trailer being moved. The tyre was destroyed and the rear wheel of the trailer bent. The tail exploder container assembly from the bomb was blown 100 feet across the perimeter track, and the bomb itself split open but remained in one piece. The damage is shown in photographs 16 -21.

17. Result of explosion with American bomb

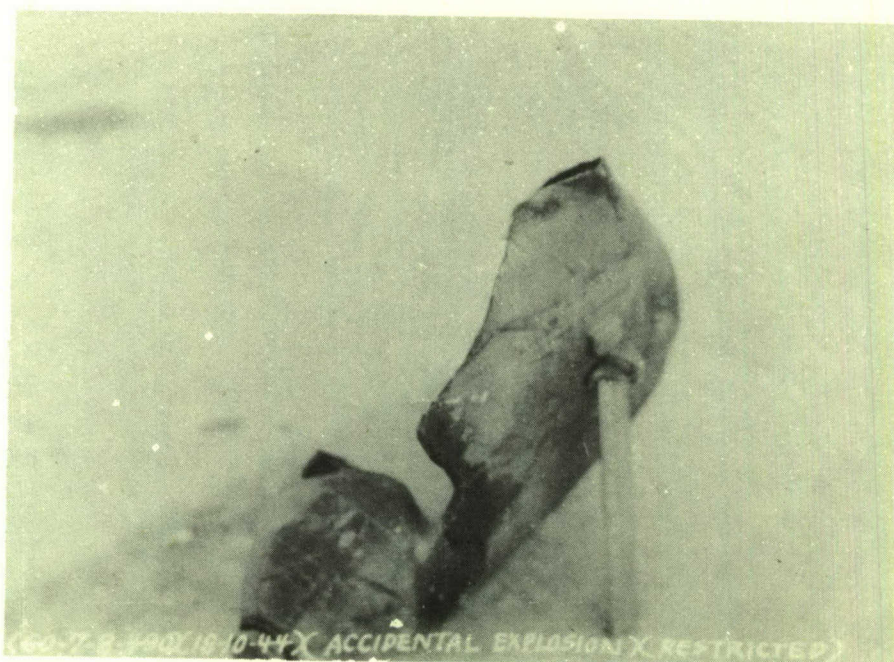
18. Result of explosion with American bomb

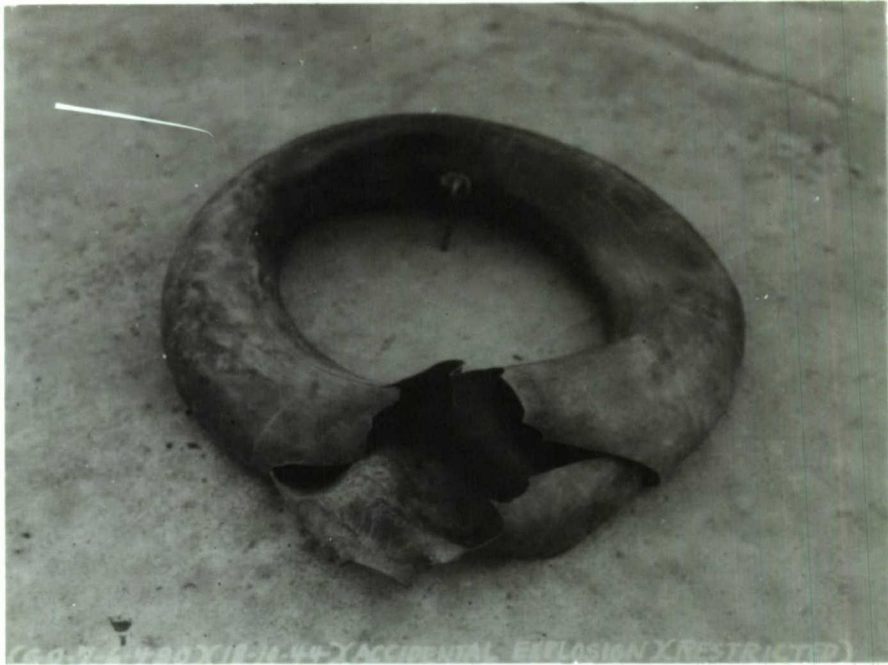
19. Inner tube of trailer tyre after explosion with American bomb

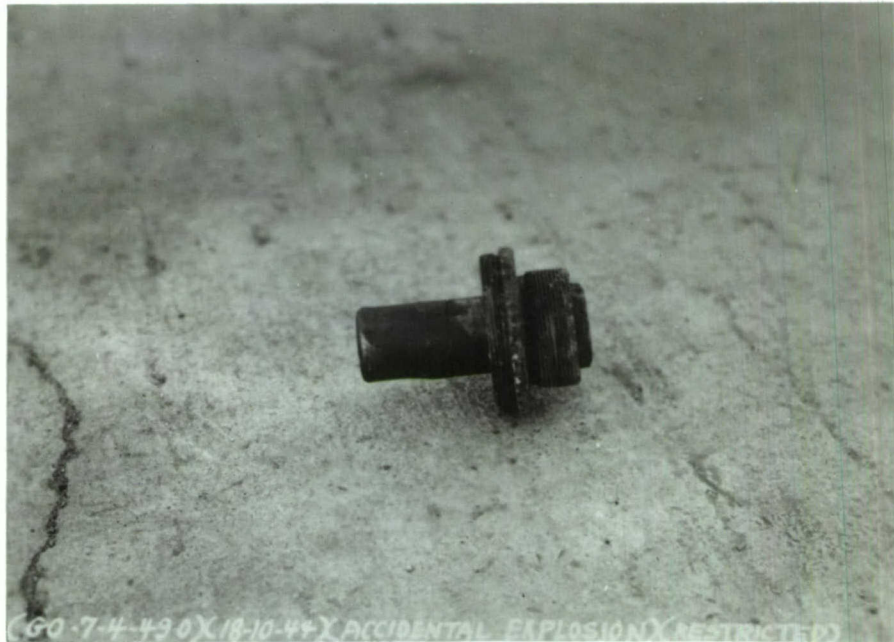
20. Exploder assembly after explosion of American bomb

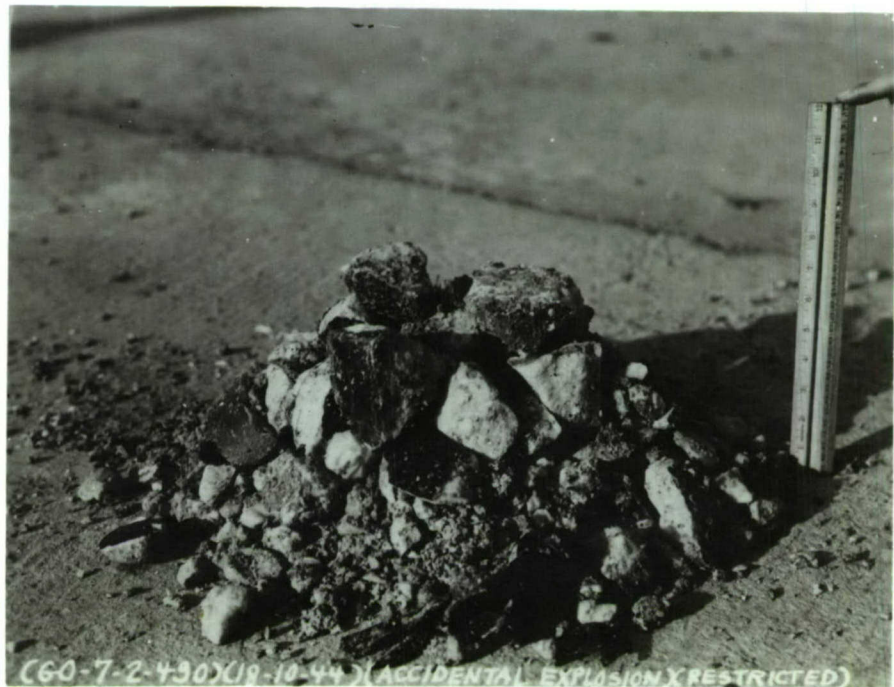
21. Filling from exploded American bomb

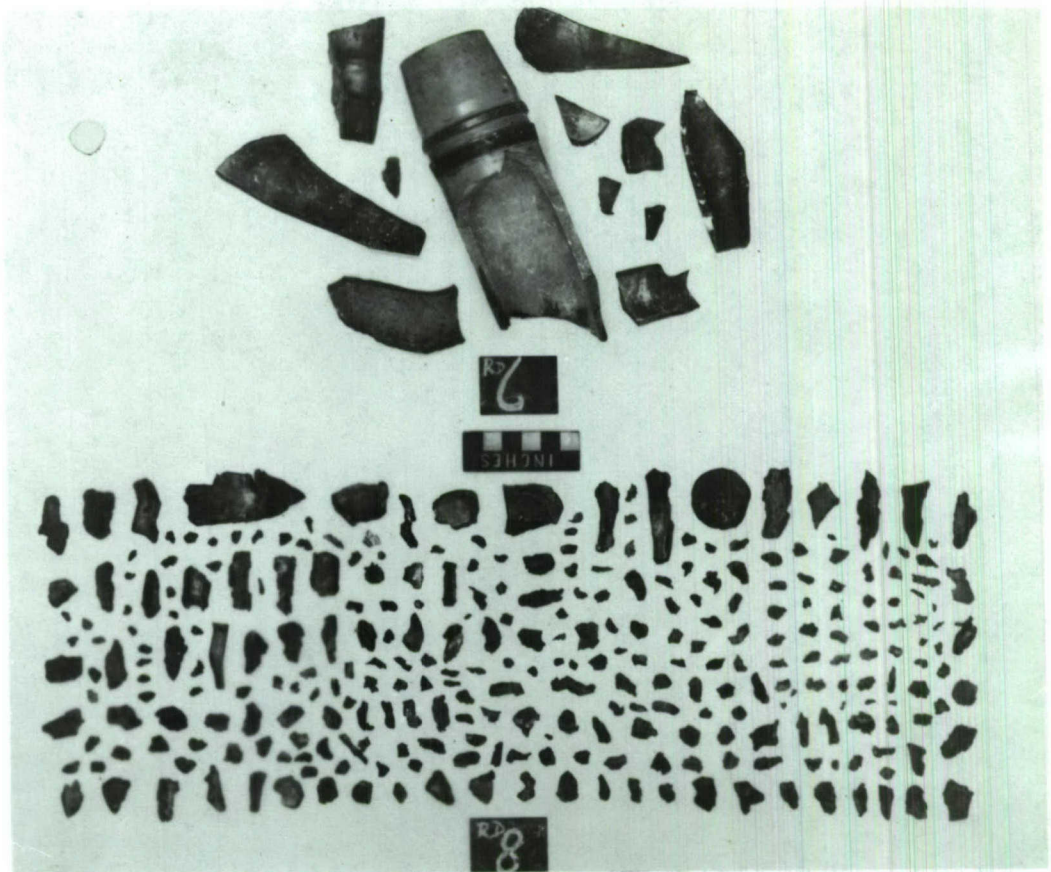
Heat input (watts)	Time to explosion min sec		Maximum temp. recorded °C	Result
1237	1	45	-	Explosion with red flash. Nose fragmented, rest of shell broken. (Photograph 24, round 6)
770 (intermittent)	11	20	167	Explosion. Good fragmentation. No flash much grey-black smoke.
375	11	54	148	Bright flash, dark smoke, probably detonation. Very small fragments. 200 yd. throw. (Photograph 24, round 8)

24. Fragments from 5.5 in. shell heating trials

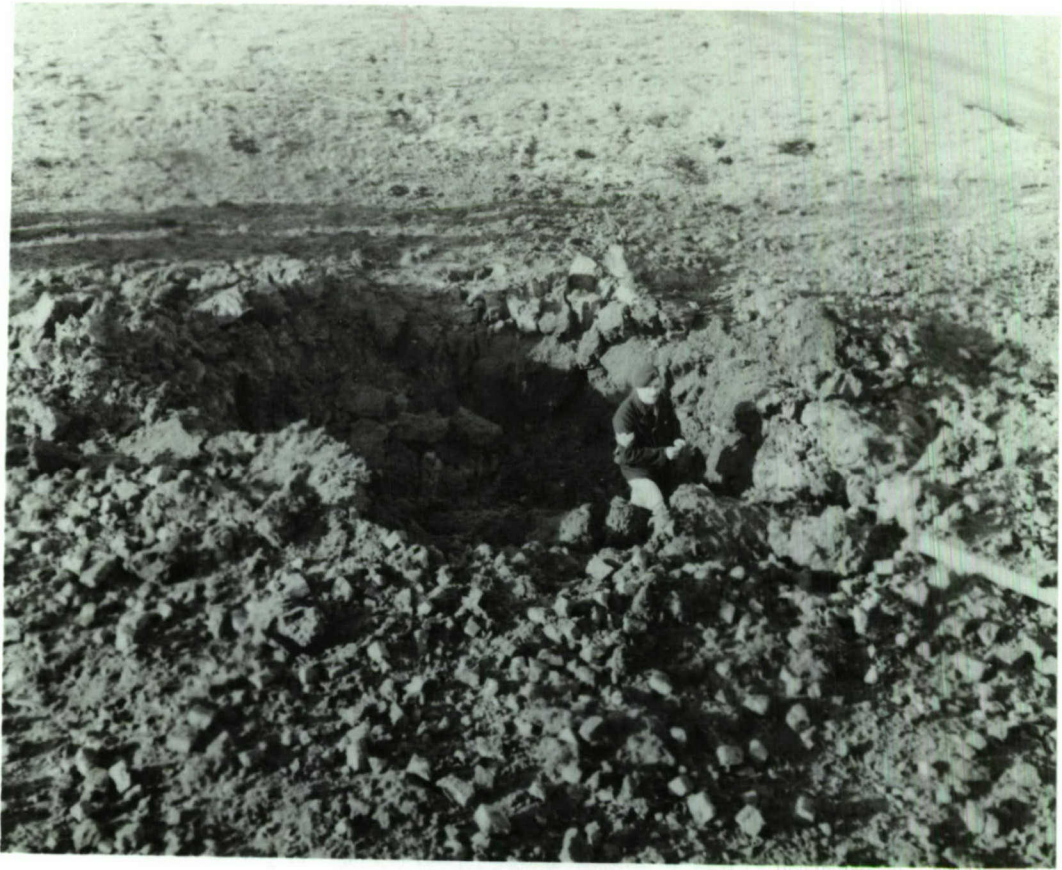
31. Crater from detonation of 1000 lb. bomb at Shoeburyness

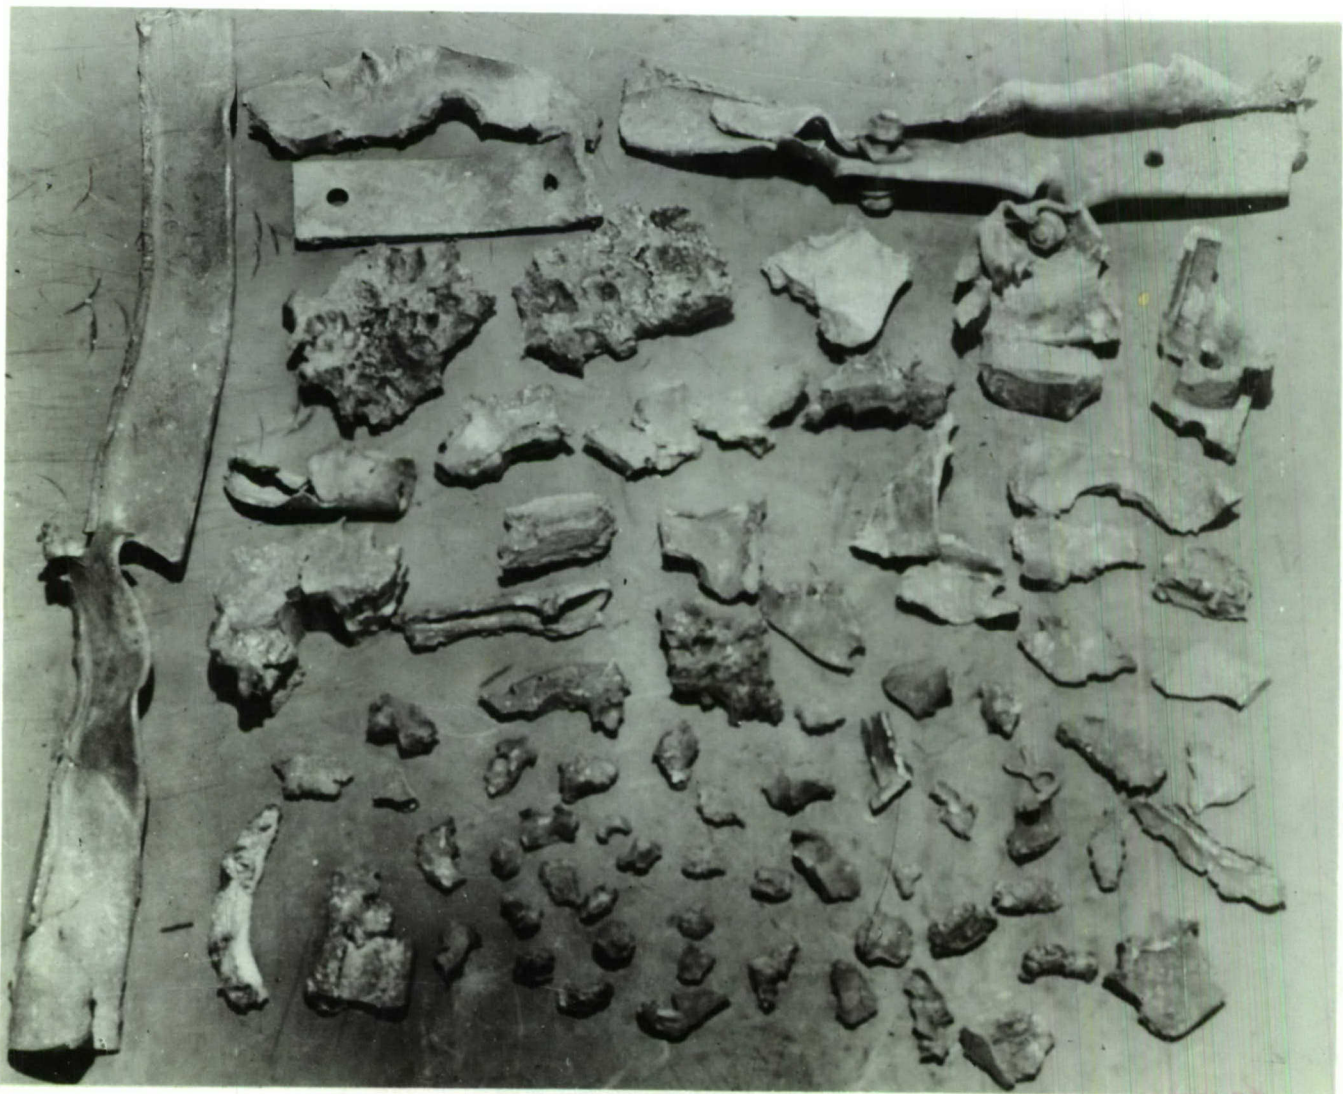
32. Fragments of apparatus recovered from crater after detonation of 1000 lb. bomb at Shoeburyness
